### Installing Demand Logic at Standard Chartered Bank

The headquarters of Standard Chartered Bank in London contains 200,000 ft<sup>2</sup> of office floor space and an energy spend of approximately £610,000. With a commitment to responsible business practices and targets for reducing its carbon emissions, as well as a drive to reduce costs, Demand Logic installed in May 2017.

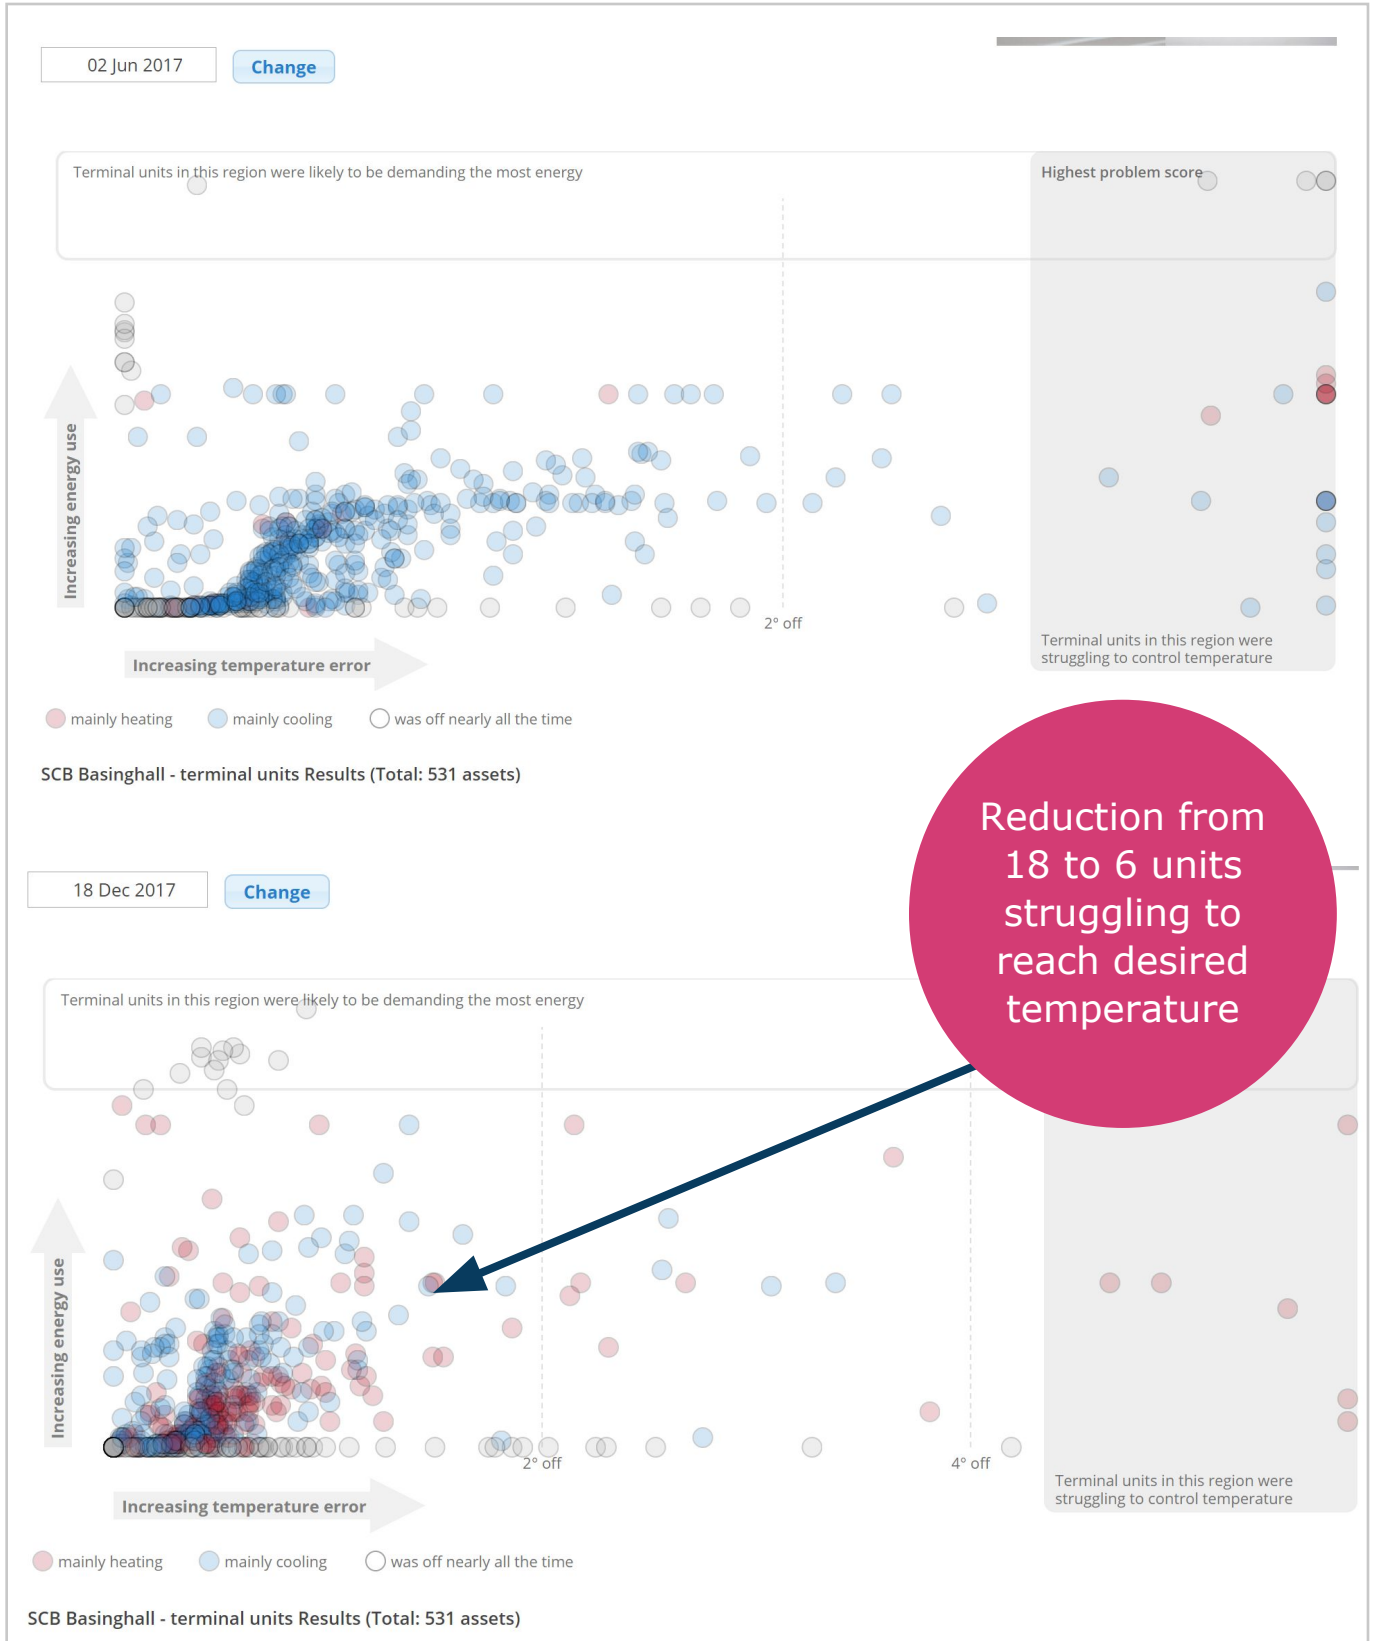
# Reducing out of hours operation

Terminal unit Rogue Finder illustrates the effect of implementing condition based maintenance
